A.I D.R. Congo - Goma - 2002 - Volcano

Distribution and technical support

Materials distribution
Self-build, with technical support

Goma volcano eruption in 2002

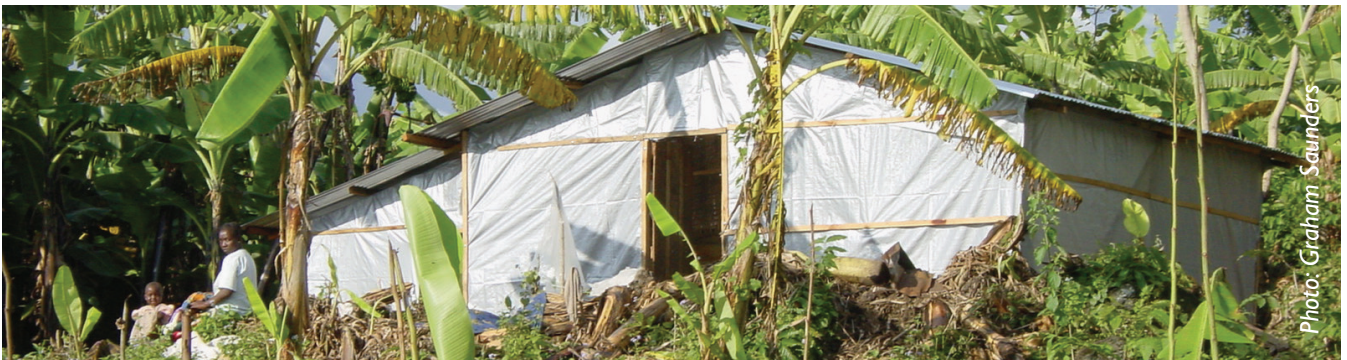
Sample of a temporary house

The transitional shelters measured 5m x 4.8m, provided 24m² of covered living space for five to six people, and followed Sphere minimum standards. The dimensions were defined by locally available timber sizes, in order to maximise section spans and minimize wastage from cutting. The traditional use of volcanic rock for walls was rejected as too slow and difficult to cut and size correctly, and too expensive to transport.

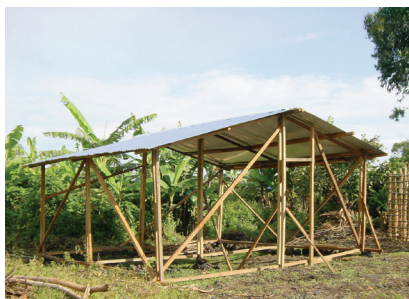
Structural skeleton of a house, showing cross-bracing

Tools and a marked length of string, used to measure out bracing sections, were supplied with each kit. Few construction problems were reported due to the simplicity and familiarity of the design.

As the budget did not stretch to timber-clad walls, the design had to be braced well enough to stand unmodified. The walls were covered with plastic sheeting held in place with timber laths and protected from the weather by the overhang of the roof.

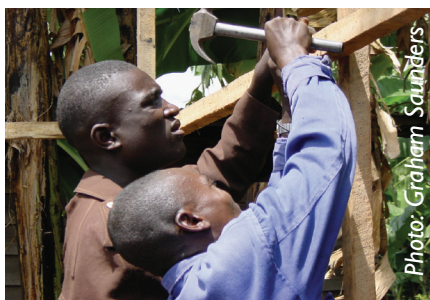
Families were trained to construct their shelters, but around 70% hired others to build.
