## A.2 Eritrea - 1998 onwards - Conflict

### Camp upgrades

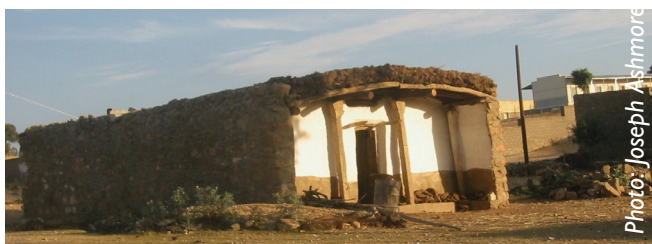
Traditional hudno house with earthen roof

Many of the camp residents in the Gash-Barka region had previously lived in houses called hudnos. These houses had heavy roofs and thick walls, which kept interiors cool during the hot day and warm during the night.

The roof of a hudno uses a lot of wood - the roof frame is covered by more wood with a layer of mud on top. The walls are generally made of stone, often using mud as mortar.

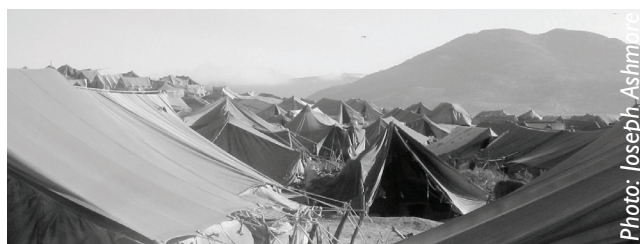
Over 60,000 people were living in tent camps six years after the outbreak of conflict.

Tents and plastic sheeting formed the core of the shelter response. Due to the short lifespan of such materials, many tents that had rotted, blown away or caught fire had to be replaced during the period of displacement.

However, nearly 4,000 replacement tents were required between 2003 and 2007. This redistribution of basic emergency shelter items was enough to rehouse nearly half of the total camp population of around 63,000 people. Considerable quantities of plastic tarpaulins were also distributed, although as some of these were distributed to returnees an exact figure for camp residents is difficult to obtain.

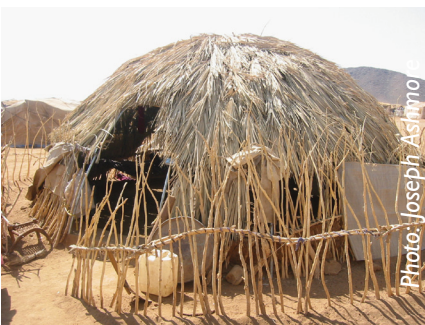
Palm leaves were distributed to 1,000 families.

There were trials with other materials. In 2001 the organisation distributed palm leaves for the repair of over 1,000 traditional homes in and around Barentu, in the Gash-Barka region. These were very bulky to transport. In 2004, woven mats were produced for one camp to provide a more traditional shelter material, but this was not extended to other camps.

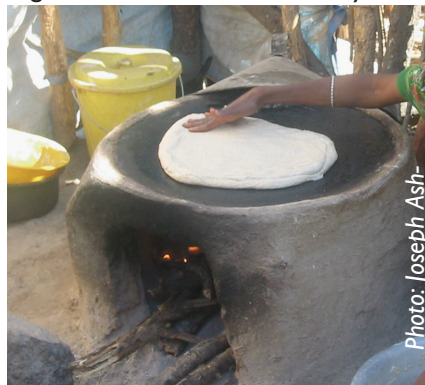
Firewood collection led to serious conflict with the host community. Because traditional stoves were not very efficient, an improved stoves project was set up.

In 2002, the organisation began the distribution of fuel-efficient stoves and kerosene stoves, significantly decreasing the demand for fuel wood by IDPs.

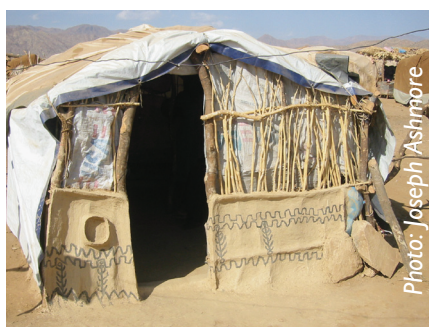
People adapted their tents in many ways.

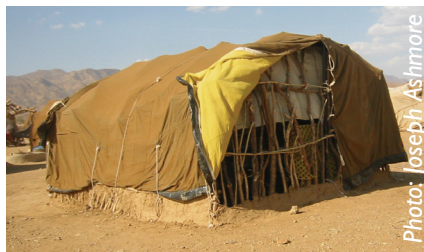
People upgraded their tents using local materials to provide more head room.

While a standard ridge tent may have walls of 80cm in height when erected with long guy ropes, tents in the camp were pitched with shorter ropes in order to save rope for other

uses and to decrease the footprint of the tent. Shortening the guy ropes meant that the wall height shrunk to around 30cm, reducing the internal volume of the tent considerably.

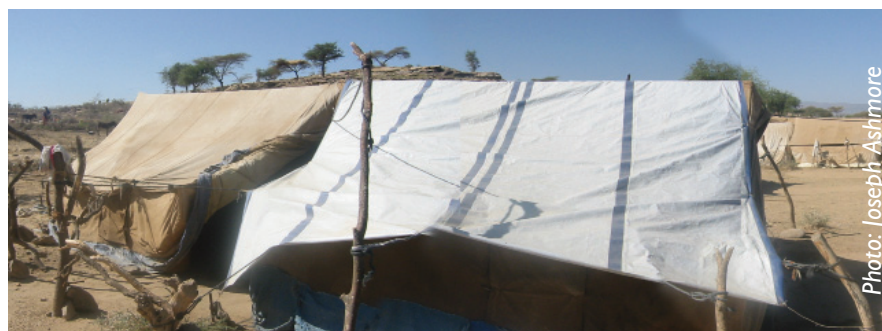
A fly sheet separated from an inner tent and covered with plastic is used to form an extension. Sticks were used to raise the sides to increase the internal volume.

**Structure:** IDPs extended the height and floor space of their shelters by building large wooden frames and hanging tents and other material over the top.

The wooden frame was constructed from logs up to three metres long. The logs were cut down locally or purchased by the IDPs themselves. The frames were not particularly efficient in the use of timber, consuming around 200kg of wood for a family shelter with considerable structural redundancy.

**Roofing:** Layers of tent canvas, plastic sheeting, grain sacks and straw mats were used as roofing materials. For those IDPs who did not possess a tent, plastic sheeting was used as an outer layer with other available materials placed over the top to prevent plastic sheeting from degrading in strong sunlight.
