## B.12 Sri Lanka - 2007 - Conflict returns

### Case study: Core shelter

Transitional shelter construction

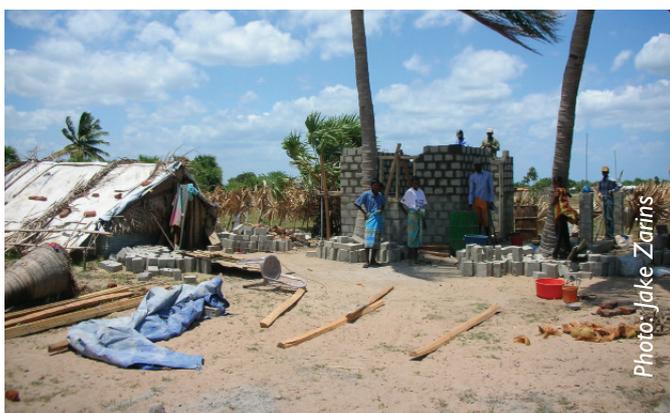
Core shelter under construction

The core shelter has a fully enclosed space, as well as a veranda area that can also be enclosed. Technical drawings were provided to demonstrate basic possible variations

to expand it in different directions (front, side). Specific features were incorporated to give the walls greater durability (stabilisation and curing of the building blocks) and greater resistance to cyclones and heavy rains (steel bar reinforcement of wall pillars, roof trusses, binding of trusses to walls, use of J-hooks for the roofing sheets, overhang of roof to protect walls from rain, adequate foundations, raised flooring). Where possible, the raised floors were built using recovered materials from the destroyed houses.

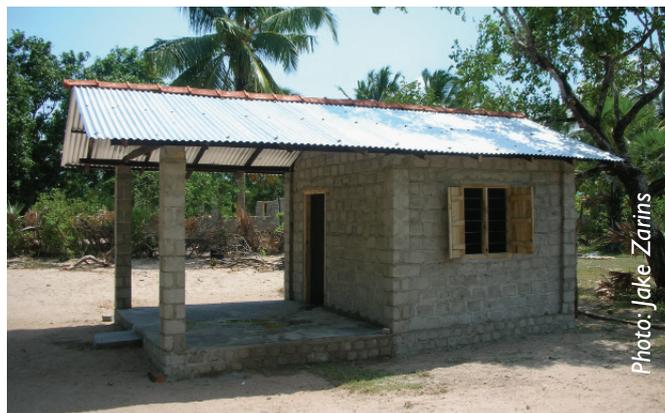
Completed core shelter

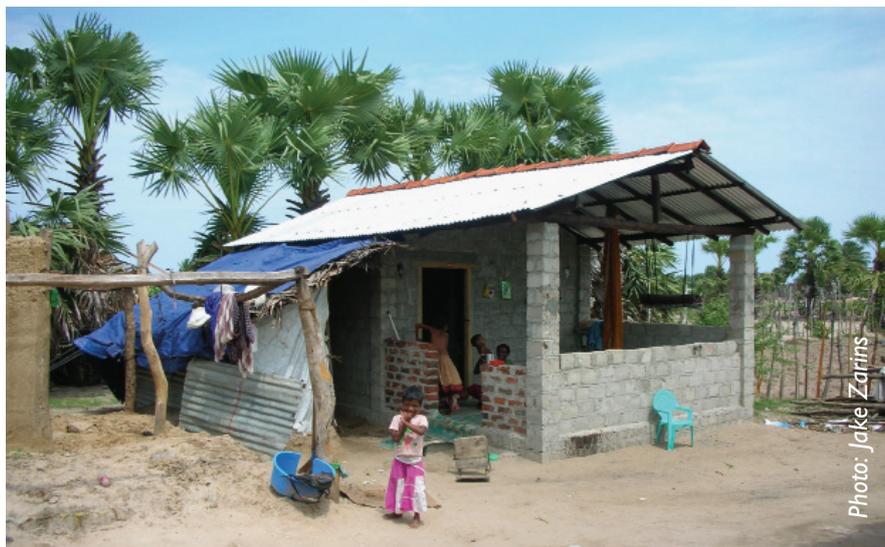
More than 80% of the families used personal resources or their own time and effort to upgrade their core shelters.

More than 80% of the families used personal resources or sweat equity to start the process of improving their shelters. Some members of the community were also able to gain livelihood opportunities by doing masonry or construction work for other members of the community. The isolation of the location and the damage to the economy caused by the conflict meant that there was little other competition for employment among members of the community.

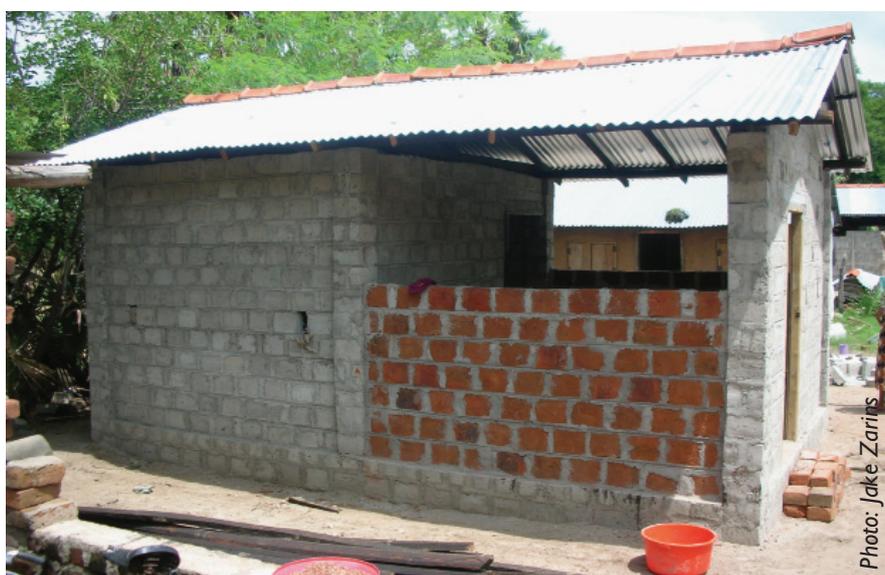
A durable upgrade of a core shelter

The beneficiaries used a variety of materials when building extensions, ranging from building blocks to plastic sheeting and palm thatch. It was estimated that the construction of each shelter would take about three weeks, including the one week needed for curing the building blocks.
