A.9 Ethiopia – 2012 – Conflict and Drought

Case Study: **Keywords:** Planned and managed camps / relocation sites, Transitional shelter / T-shelter, Site planning

Ethiopia

Dollo Ado

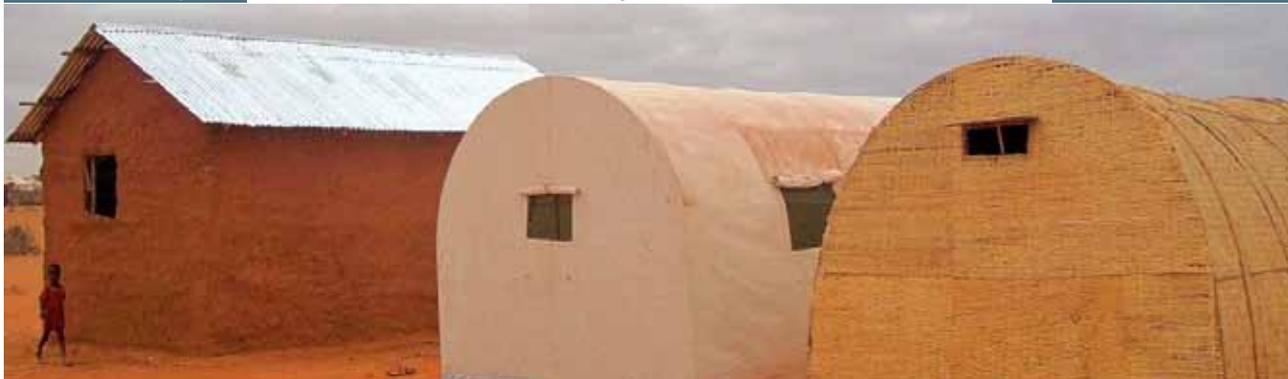
Three different prototype shelters were built and a group of refugee representatives, the government and the key organisations agreed on a common design
Image: NRC

The model selected had a corrugated iron sheet roof, a eucalyptus post-and-beam structure and split bamboo wall cladding. The intention was to plaster the walls with mud.

The shelter had an internal partition, two lockable windows, and a door that could be locked both from the inside and the outside for improved security. Corrugated iron sheet was chosen for roofing on account of its durability and fire safety.

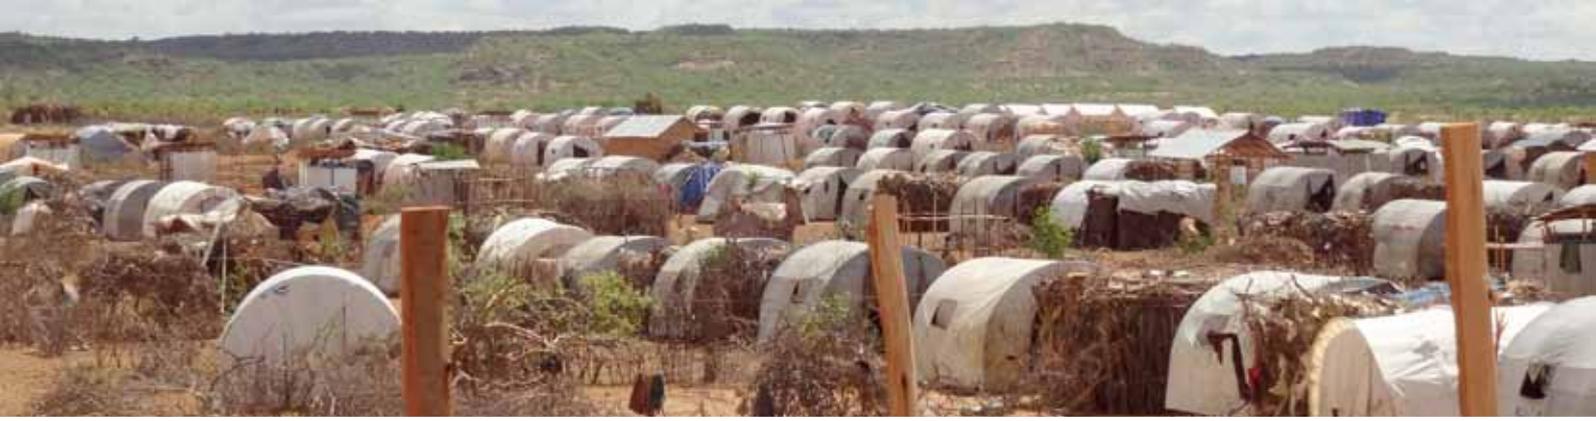
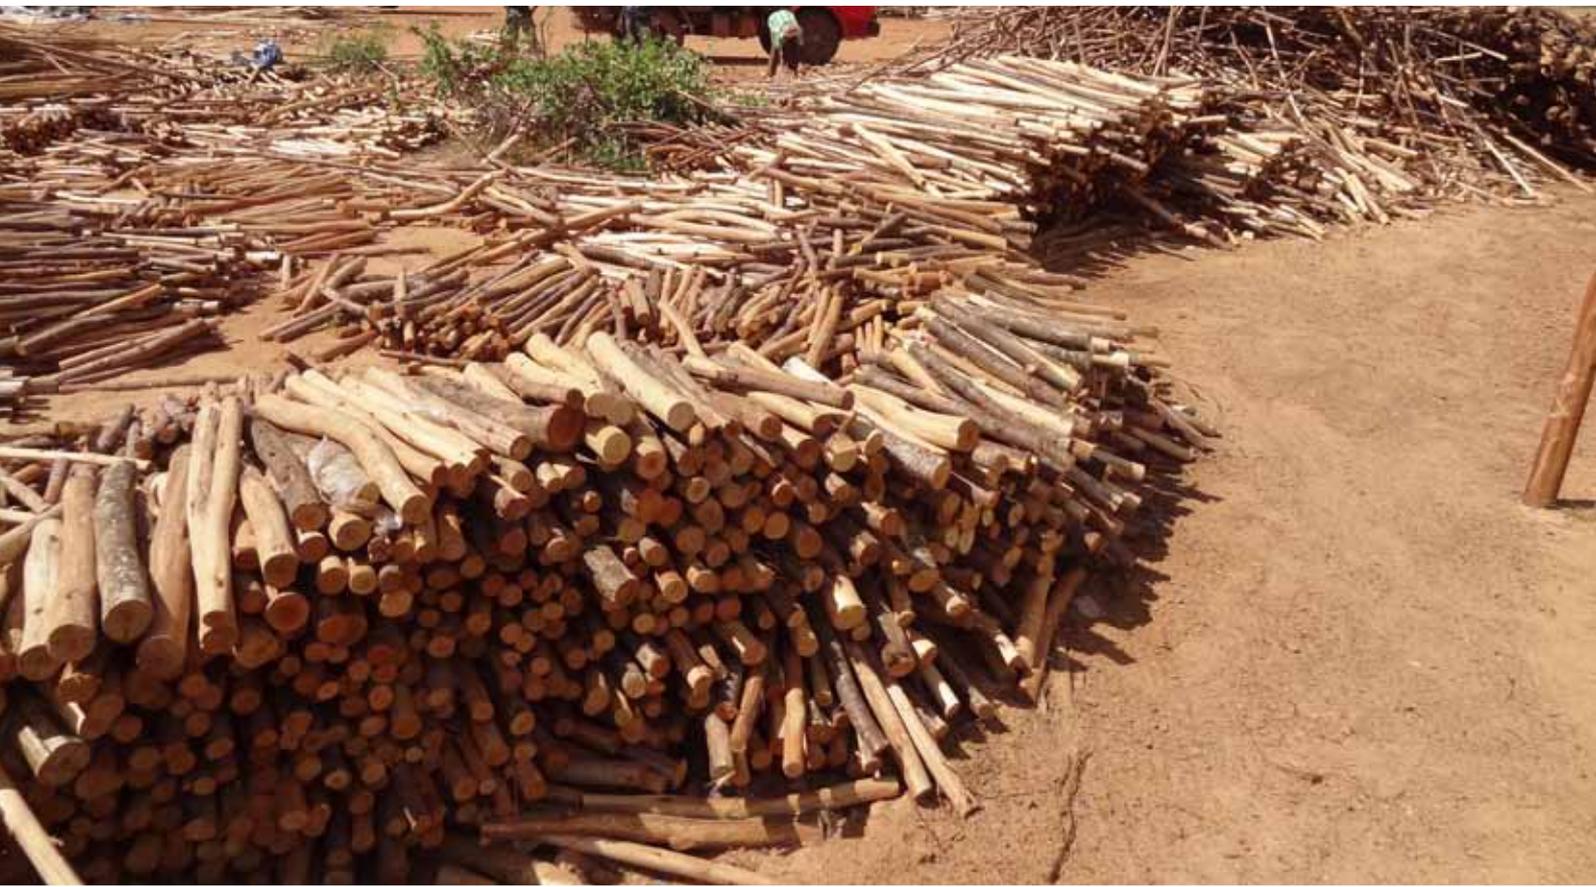
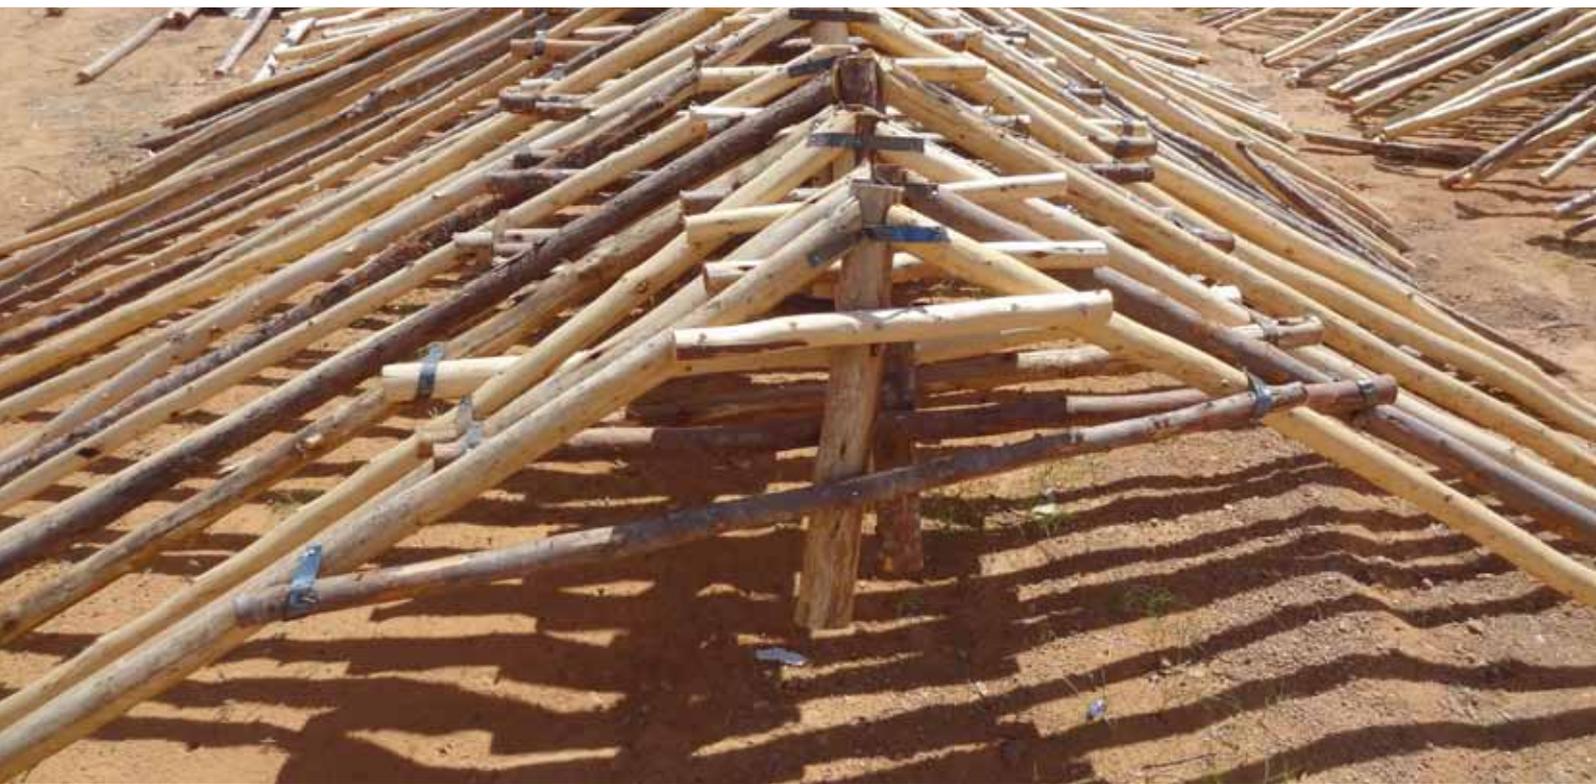
Top: View of a camp before construction.
Each organisation established a large workshop in each camp to store materials and prefabricate components.
Images: Joseph Ashmore

Each organisation established a workshop and materials storage area close to construction sites. In the workshops, timber was pre-cut, bamboo was split, and doors, windows and roof trusses were prefabricated.

A well-organised workshop with effective quality-control mechanisms was necessary to maximise production efficiency. The minimum workshop and storage area for efficient production was 1 hectare (10,000m²). Workshops were staffed by a mixture of skilled carpenters and daily labourers.
