B.4 Indonesia - Aceh - 2004 - Tsunami and earthquake

Case study: Shelter or housing?

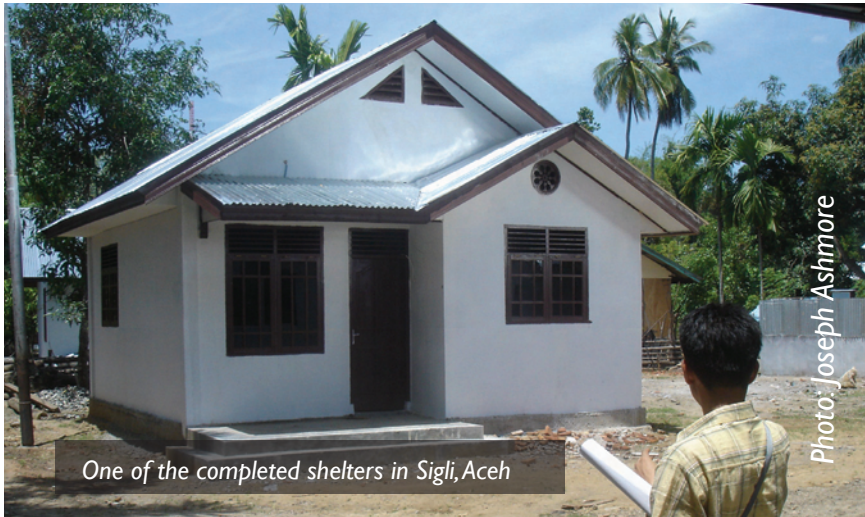
One of the completed shelters in Sigli, Aceh

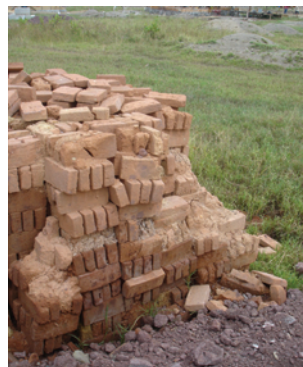
Obtaining good quality building materials remained problematic. These bricks decayed rapidly in the rain.

The availability of materials strongly impacted the shelter designs used. There were significant challenges in

obtaining legal timber locally, while importing timber was slow and problematic. Strangely, the amount of wood burned to make bricks may have had a larger environmental impact on the local forest resources than using timber would have done.
