B.3 Bangladesh - 2007 - Cyclone Sidr

Core shelter, repair and awareness

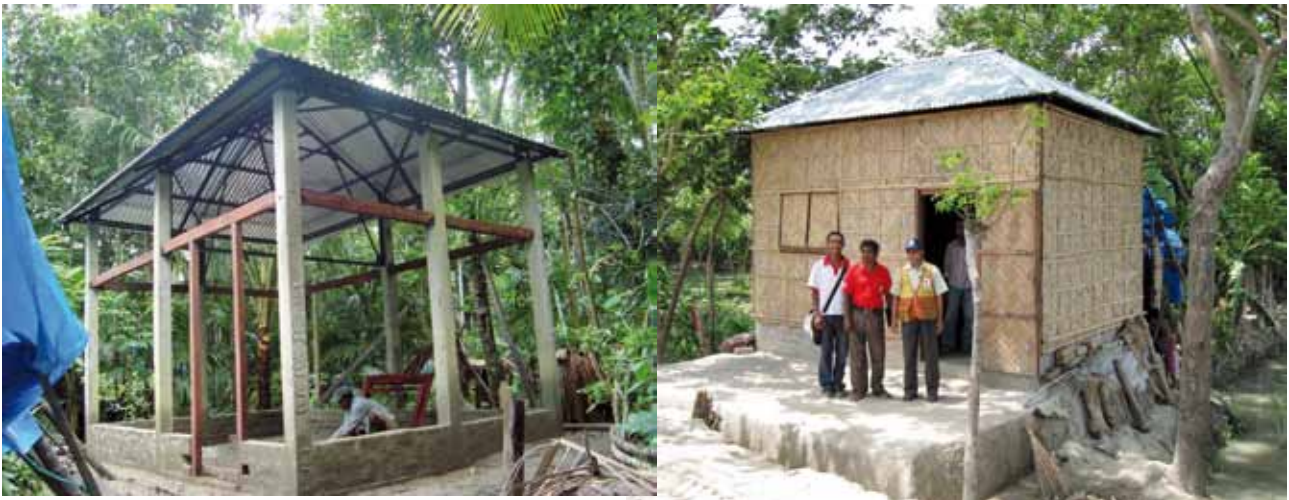
The core shelters were built by contractors and selection of families was through a lengthy transparent process
Left shows the frame of the structure
Photos: Xavier Génot, IFRC

The core shelter was built on a mud plinth to protect from flooding. It was anchored to the soil by the 8 reinforced concrete columns with 5 feet deep foundations. The structure was braced, had a six-

The walls were made from woven bamboo mats. These were found to be cost-effective, environmentally friendly and allowed families to replace or repair them.

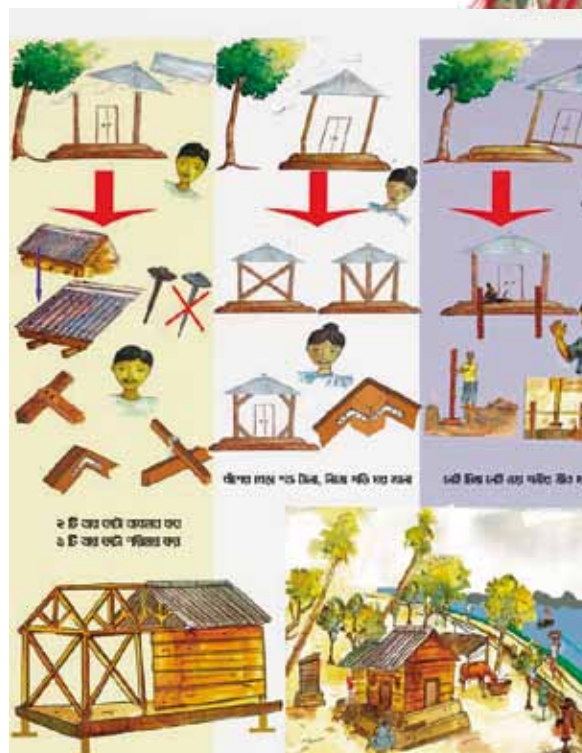
Below: training poster developed for the Sidr Programmes

Training events in safe shelter awareness were interactive and took about three hours. They were conducted in sessions attended by between 20 and 25 people, led by two people and monitored by one observer. Trainings were to help families to assess their shelter vulnerability, help families to strengthen their shelters (with focus on bracing, foundations and roofing), and to present toolkit components.
