## C.10 India - 1977 - Cyclone

### Case study: Traditional or modern shelters

Case study credit:  
UNDRO 1982

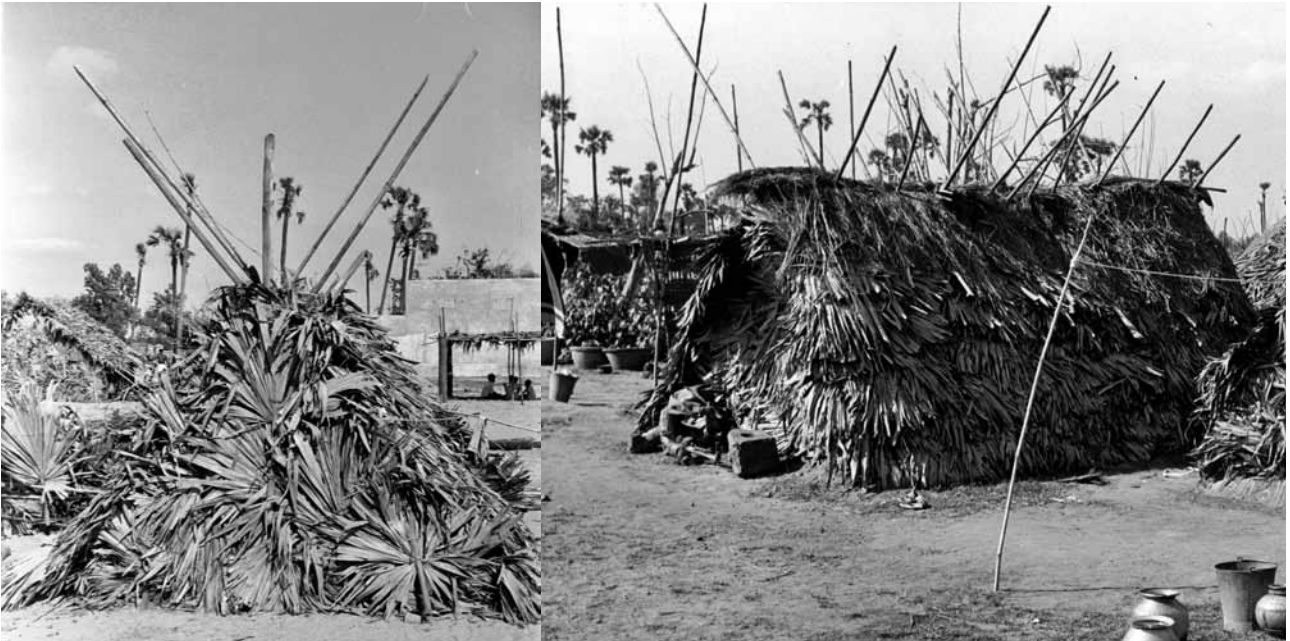
The government made stocks of thatch and bamboo available so that families to improvise shelters. Non-governmental organisations also built many thousands of these shelters.  
Photos: Ian Davis

The climate was warm and the monsoon season not imminent, so shelter needs were not a high priority, The Government made stocks of thatch and bamboo readily available for families to improvise shelters, and repair or rebuild their homes.

An international non-governmental organisation, worked through Indian voluntary agencies to build 7,000 shelters in 90 days.

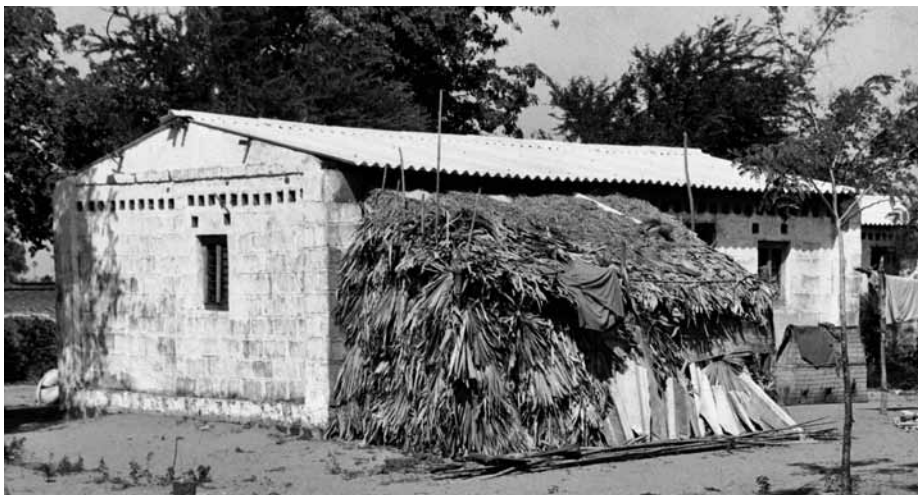
Housing by a reconstruction organisation built in 1969 following the cyclone, with lean to in the foreground. In the village many of the families evacuated most of the concrete block housing to live in improvised thatch lean-tos which are climatically more suitable.  
Photo: Ian Davis

- ✓ The government adopted a Preparedness Plan which included 13,000 community cyclone shelters.
- ✓ Evidence suggested that the concrete block housing has had a positive effect in the local economy.
- ✗ Despite the minimal need for emergency shelter and pressing agricultural priorities, one agency devoted extensive resources (US Government aid) to build 7,000 shelters. This was mainly the work of contractors, generating limited local employment.
- ✗ Opportunities were missed to instigate training

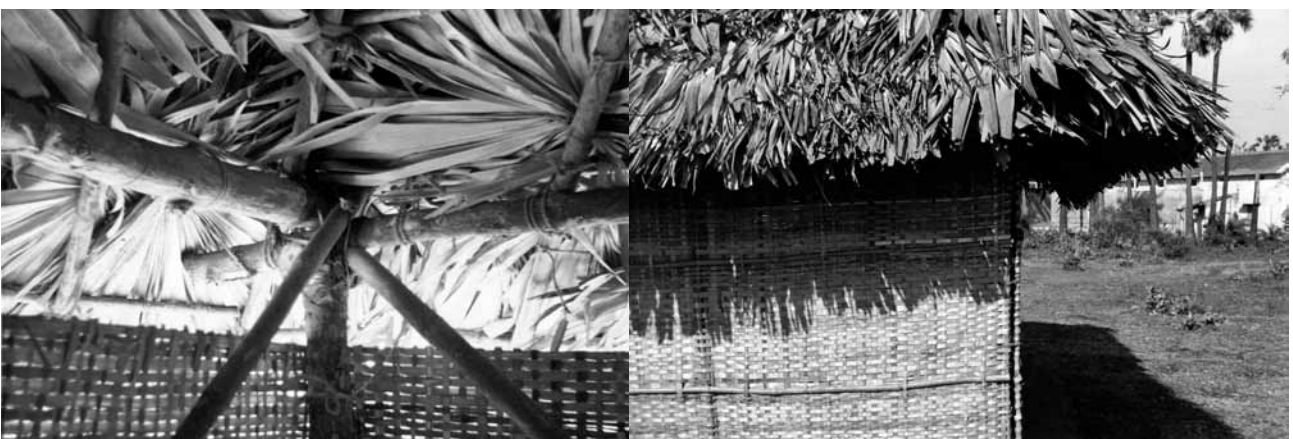
Details of a model home built out of bamboo and thatch to explain a safer techniques in cyclone resistant housing. It had key elements of: a well-anchored central post, triangulation to stiffen the frame, good connections of roof to wall using metal connections  
Photos: Ian Davis
